Evaluation of accelerated bridge construction methods and designs in the state of Iowa

MASTER OF SCIENCE

Major: Civil Engineering (Structural Engineering)

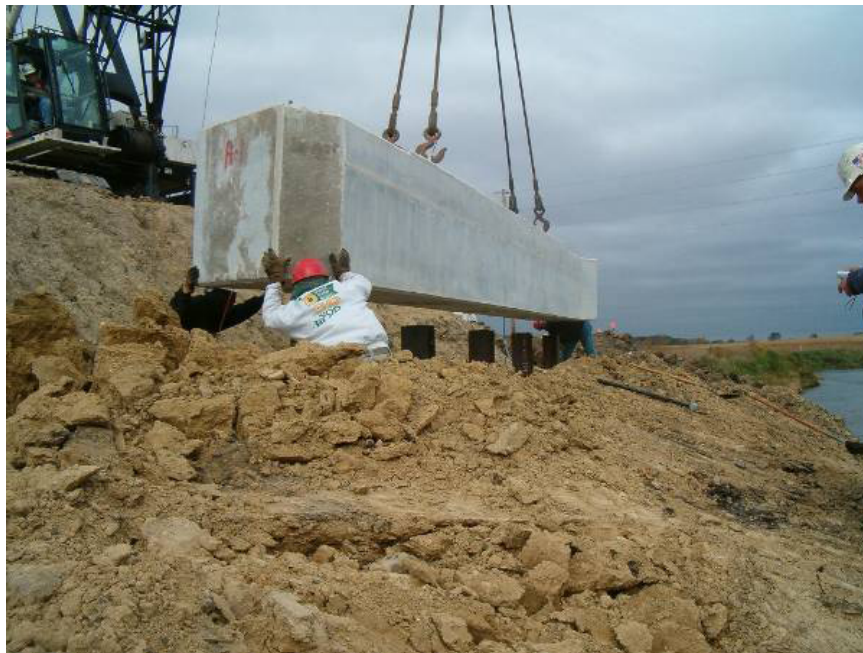
Construction of the new bridge began with the driving of the piles. Special care was taken during this process to meet the lateral end of driving tolerances. End of driving tolerances were small because the precast cap beams had to slip over the piles ends. After the cap beams were set in place, a high strength grout was used to quickly secure the joint by filling blockouts in the cap beams. A photo of one of the abutments being installed onto the piles is shown in Figure 5.

Figure 5. Placement of precast abutment cap onto H-piles

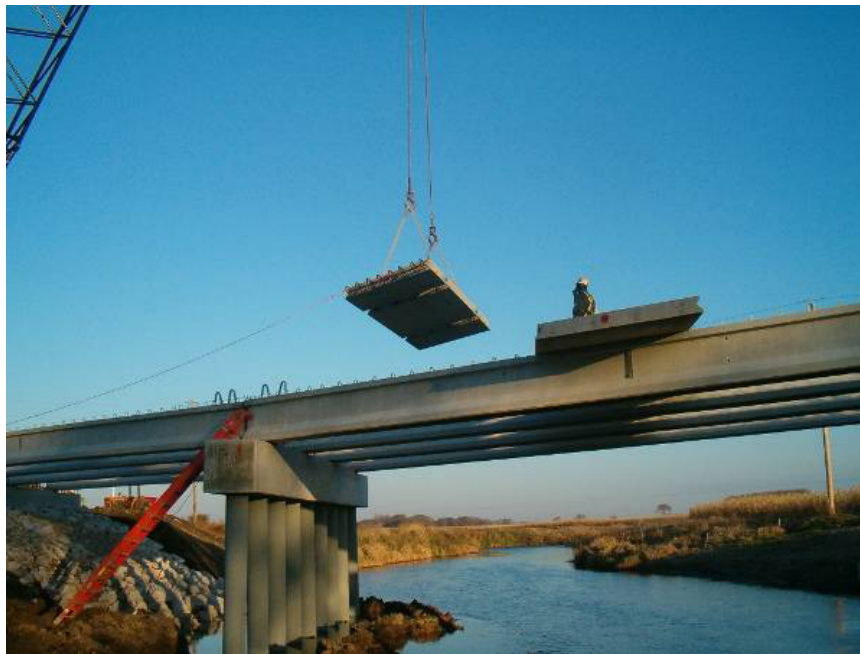
panel delivery began. The panels were delivered to the site three at a time; half of the panels arrived the first day and the other half the next. Placement of the first half of the deck panels took one full day while installation of the other half only took half a day. This observation demonstrates a relatively steep learning curve sometimes associated with precast construction methods. A photo of a typical deck panel being installed is shown in Figure 6.

Figure 6. Installation of a precast concrete deck panel

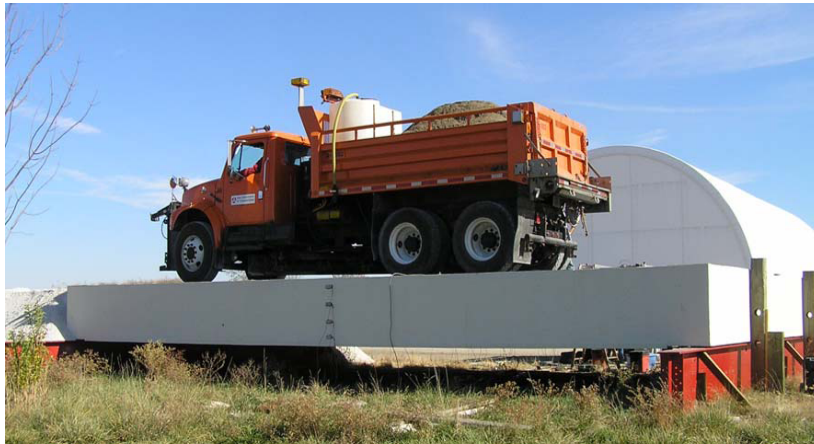
Temporary bypass bridges are used in a number of construction applications. These bridges are generally small in size and are manufactured in more complete sections for easy assembly. Traffic disruption is reduced by using these bridges to create detour routes or to temporarily replace damaged existing bridges. For many years the Iowa DOT had employed the use of prefabricated steel bridges for these structures. In 2003, the Iowa DOT began research on the use of fiber-reinforced polymers (FRP) as a means of creating a lighter, more durable, and easier to construct bypass bridge. A photo of an FRP bridge being tested is shown in Figure 7.

Figure 7. Gravel truck applying load at test site

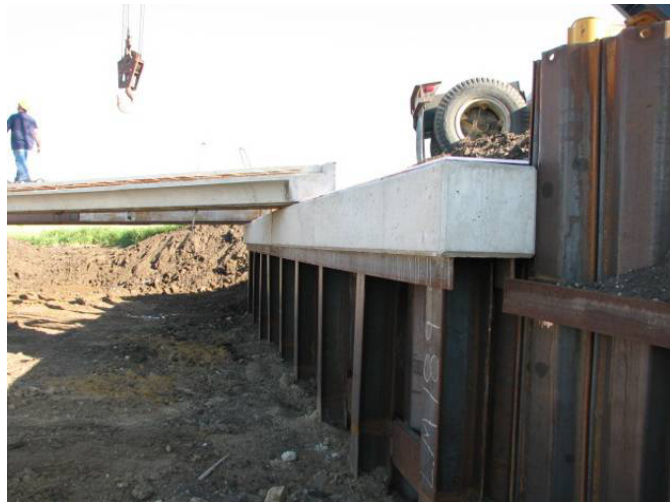
Construction of the bridge began with the installation of steel H-piles at each abutment; the H piles were arranged for strong axis bending. Once pile installation was complete, the abutment caps were placed. The abutment caps were placed so that the W-section in the cap sat directly on the H-piles as seen in Figure 12. This connection provided a degree of lateral restraint to the abutment cap.

Figure 12. Precast concrete abutment cap supported by steel H-piles

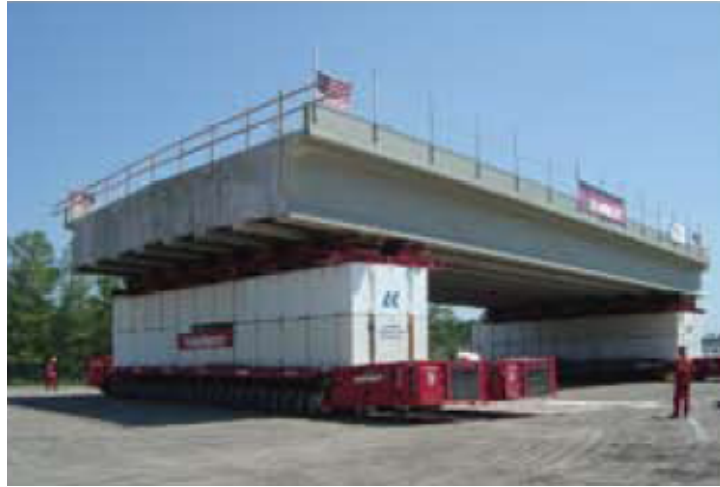
For example, one piece of equipment that shows much promise for success on ABC projects is the self-propelled modular transporter or SPMT. An SPMT is a computer-controlled vehicle that is used to move and lift very heavy objects. This machine is extremely useful for rapid construction because a bridge superstructure can be removed and replaced in as little as one night. An individual SPMT is made up of 4 or 6 axles, each axle composed of 4 wheels. A pair of SPMT vehicles are shown in Figure 20 transporting a bridge. These vehicles have been used in Europe, but have seen limited use in the United States. The major downfall of using SPMTs is that they are very expensive to use and can only be used in areas where a clear delivery path is provided from the erection site to the bridge (Ralls, Tang and Russell, 2005). Such an approach to ABC for rural bridge would not be feasible.

Figure 20. SPMTs used to transport an entire bridge superstructure

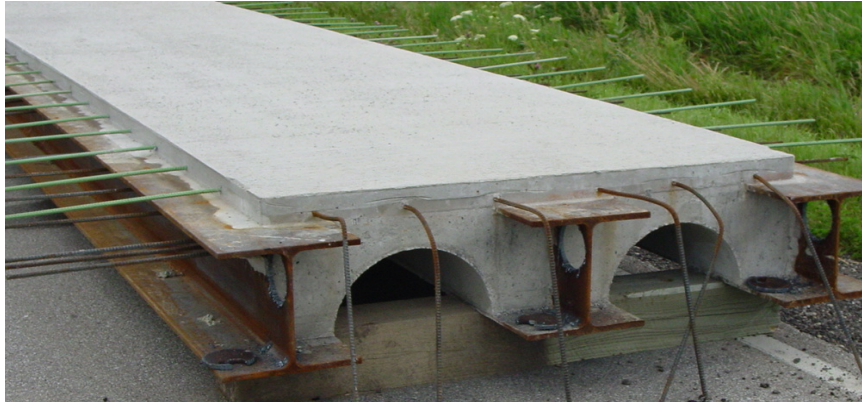
Figure 24. PMBISB system deck panel used on Black Hawk County Bridge

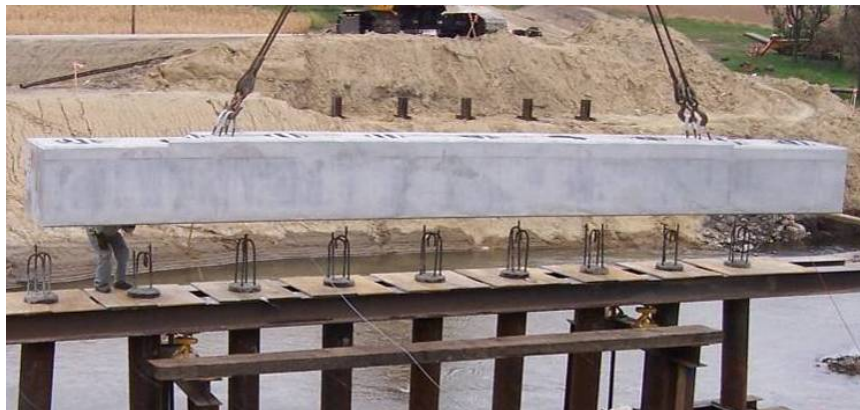
The precast concrete abutment and pier caps are connected to the piles using a cast-in-place joint. This connection is shown in Figures 29 and 30. Blockouts are created in the abutment and pier caps at the location of each pile. These blockouts were filled with a high early strength grout to speed up construction time. A high range water reducer (HRWR) was used in the grout mix to increase the slump to 7 inches. This slump level ensured that the grout flowed completely into the congested blockouts. The precast substructure caps were each installed in fifteen minute time periods and grouted the following day (Bowers, et al, 2007).

Figure 30. Installation of precast pier cap at Boone County Bridge

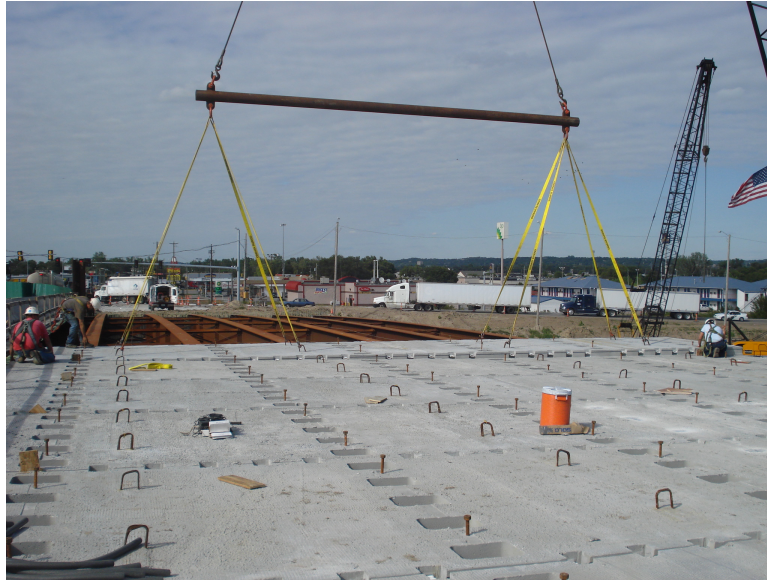
A total of seventy precast concrete panels were used to make up the deck. Each panel had a thickness of 8 inches with a length of 10 ft and a width of 52 ft 4 in. The panels were pretensioned in the transverse direction and were post-tensioned in the longitudinal direction. A photo of one of these panels being placed in the field is shown in Figure 43. The width of these panels matched half of the width of the bridge creating an opportunity for the bridge to be constructed in two stages.

Figure 43. Installation of precast deck panel at 24th Street Bridge
